**Factory name:** Baoding Tongli Garments Co., Ltd  
**Site amfori ID:** 156-044226-001

**Report No.:** JSASCN24297913  
**Audit Date:** Aug.12-13, 2024  
**Page 1 of 6**

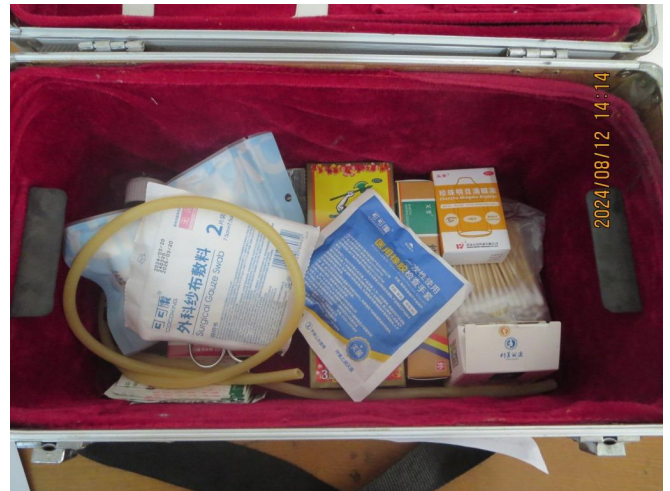
First aid kit

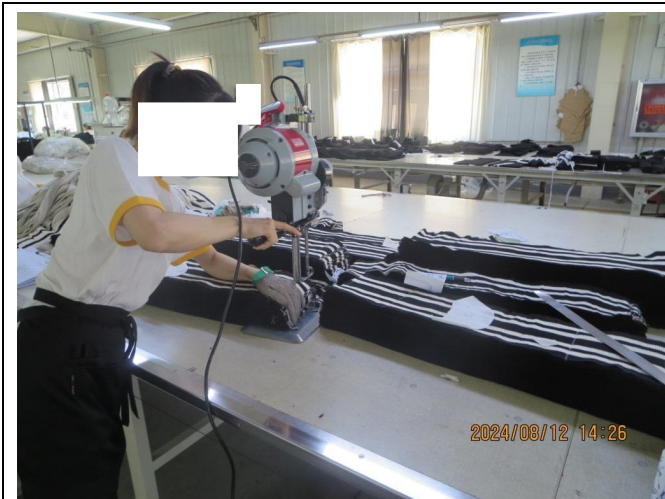
PPE was provided

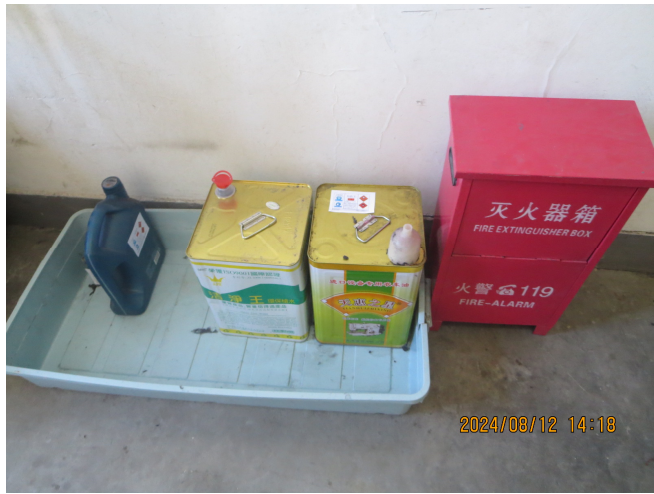
Chemical sign and second containment

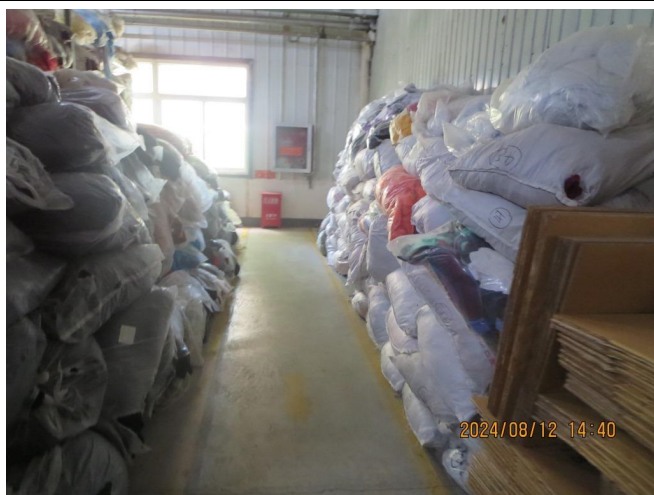
NC: Some materials were stacked against the wall at warehouse

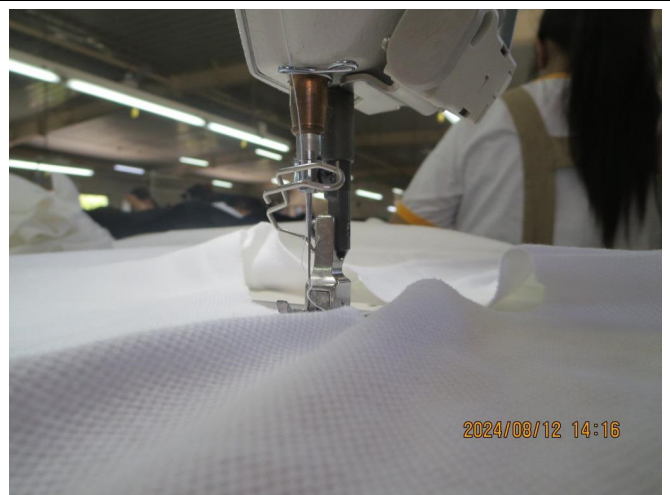
NC: The finger guard of one sewing machine was installed too high

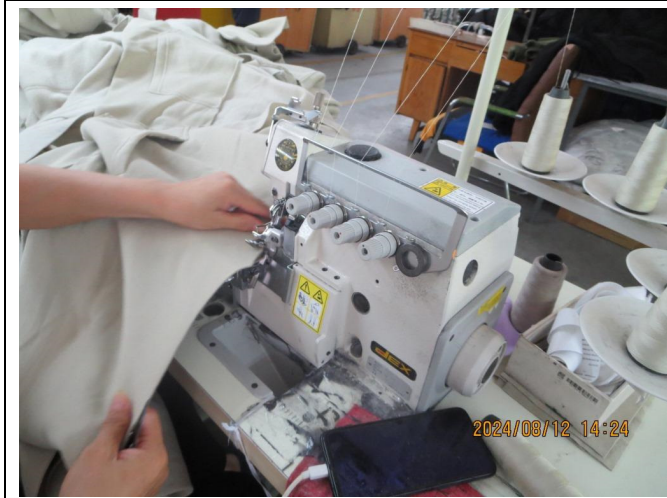
NC: The factory did not install eye guards for two locksmith sewing machines.
